Manhole Inspection Summary

Manhole # S37A2_002MH

Location Address: **4010 3rd St**

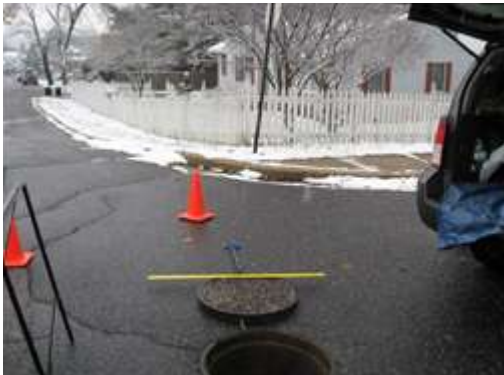
Location View

4010 frankle & 3rd

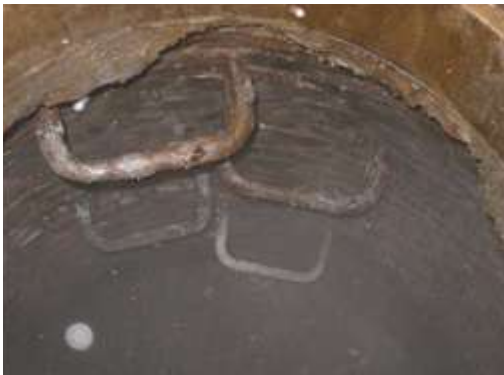
steps

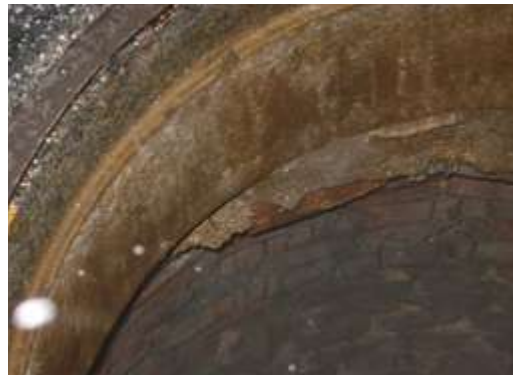
Defect 1

Condition: ☐ Sound ☐ Cracked ☐ Root Intrusion ☒ **Loose Brick** ☐ Deteriorated

loose brick & mortar on chimney

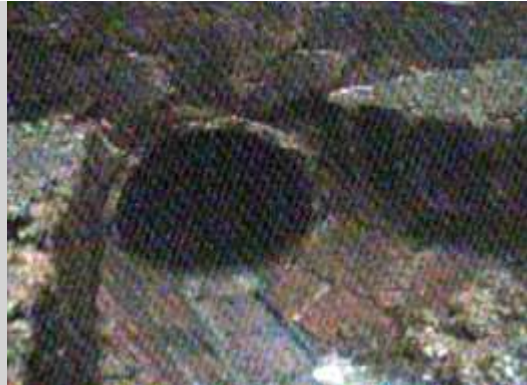
12 O'Clock Outflow

8 in. Circular Gravity Sewer
Pipe Out @ 12 O'Clock

Pipe Height: **7.2** (in.) Rod and Bar (Angled)
Pipe Material: **Clay** ☐ Pipe Lined
Invert Depth: **9.24** (ft.) Flow Characteristics: **None**
Deposits: ☒ None ☐ Mud ☐ Sludge ☐ Debris ☐ Grease
Silt Depth: (in.) Deposits Extent:
Infiltration: **None** Pipe Seal Cond: **Sound**

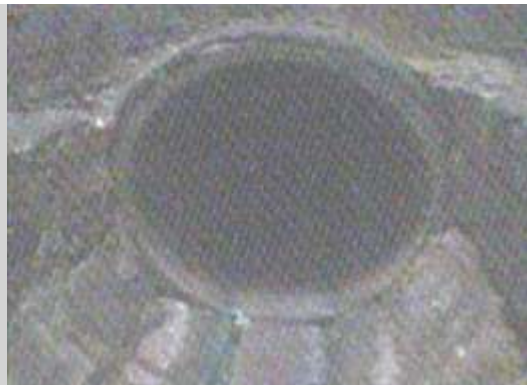
3 O'Clock Inflow

8 in. Circular Gravity Sewer
Pipe In @ 3 O'Clock

Pipe Height: **7.2** (in.) Rod and Bar (Angled)
Pipe Material: **Clay** ☐ Pipe Lined
Invert Depth: **8.67** (ft.) Flow Characteristics: **None**
Deposits: ☒ None ☐ Mud ☐ Sludge ☐ Debris ☐ Grease
Silt Depth: (in.) Deposits Extent:
Infiltration: **None** Pipe Seal Cond: **Sound**
